Final Report:

Field Evaluation of Thermal Performance and Energy Efficiency of ccSPF Retrofitted Vented Residential Attic

DCA ID #: 10-RC-26-13-00-22-210

Report No. UF01-10
21 July 2010

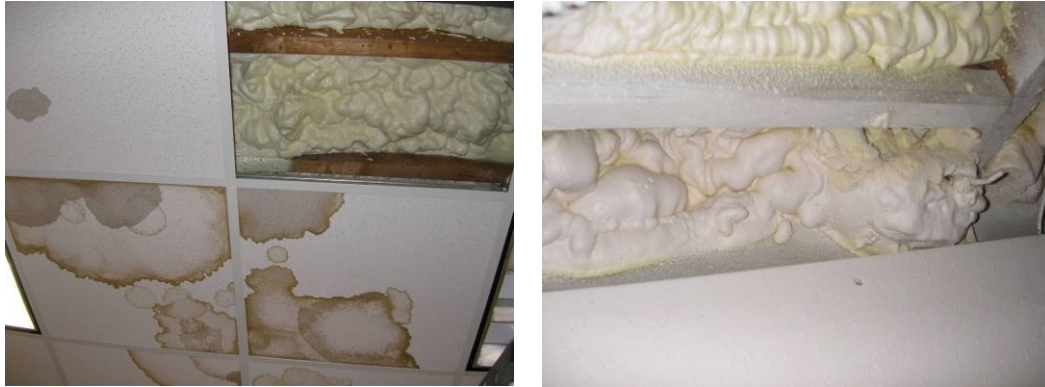
The contractor also installed a 3 in. thick layer of open cell spray foam insulation in his office. Figure 3.5 shows a photograph of the installation with water-stained ceiling tiles below the roof structure, confirming the water-permeability of open cell spray foam insulation.

Figure 3.4: Office roof with ocSPF installed

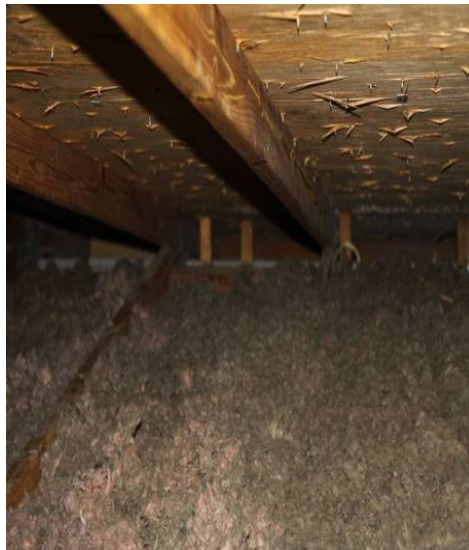
The insulation also has been blown into the attic Figure 5.10. However, there is no insulation in the attic space over garage and also there is no ridge vent. Protruding nails through OSB sheathing can be seen all over the roof. The layout of HVAC in the test house is shown in Figure 5.11.

Figure 5.10: Blown Insulation and protruding nails from sheathing

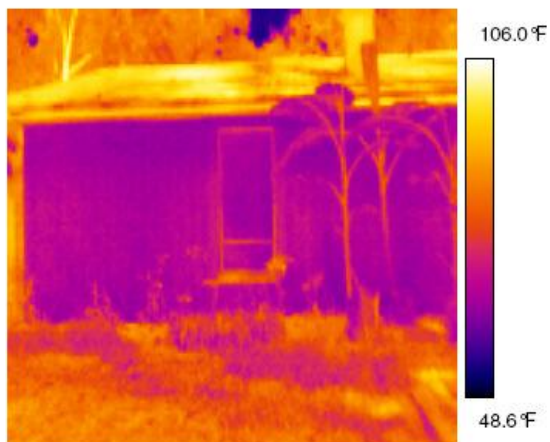
11) Looking west at back (east) side of house. No anomalies

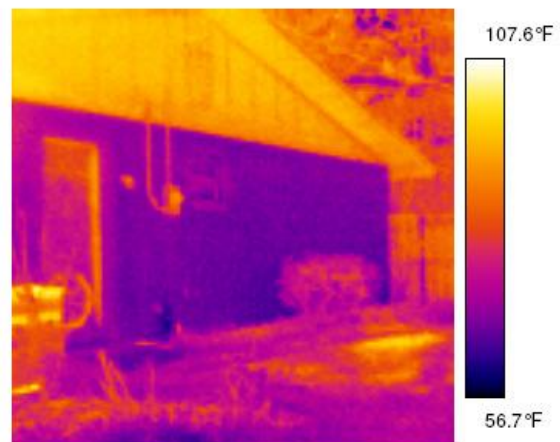
12) Looking north east at south side of house. No anomalies

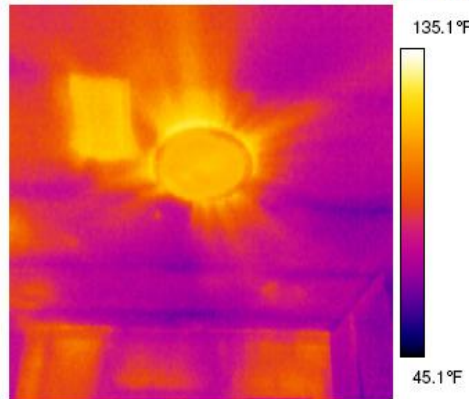
13) Looking north at air infiltration around kitchen skylight

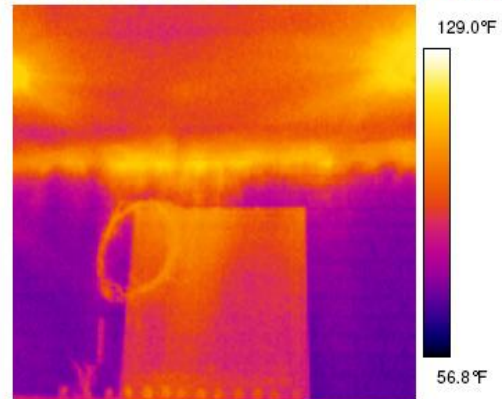
14) Looking south at air infiltration around fireplace trim

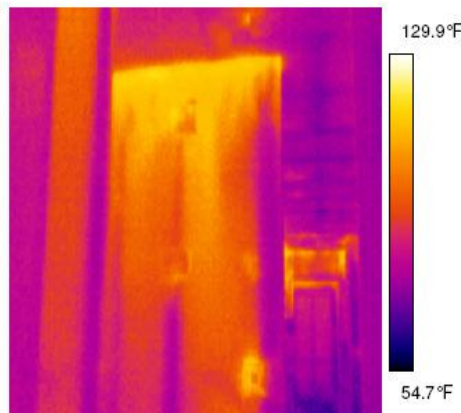
15) Looking north at air infiltration into wall between hall and kitchen. Could be from wire holes not sealed in attic

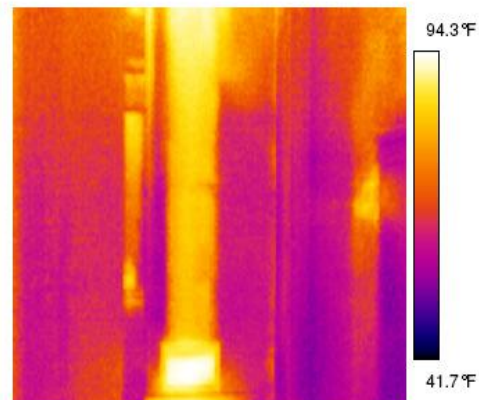
16) Looking west at air infiltration into wall return on north end of hall (typical throughout the house). Gaps around metal ductwork going into wall cavity should be sealed from the attic

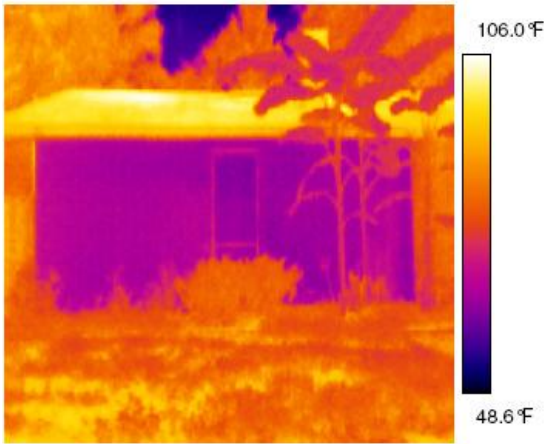
11) Looking west at back (east) side of house. No anomalies

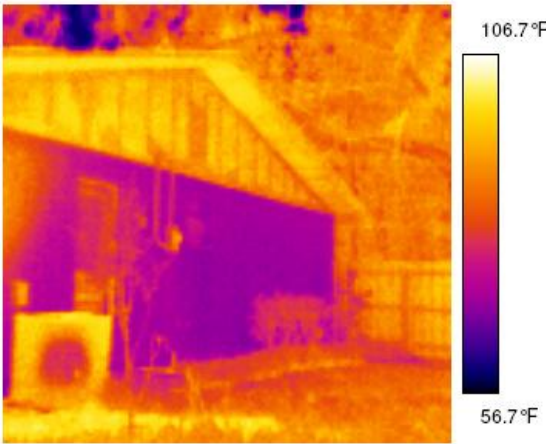
12) Looking north east at south side of house. No anomalies
