Final Report:

**Improving the Wind Uplift Capacity of Wood Roof Panels
Retrofitted with ccSPF Adhesives**

Report No. 04-07
19 October 2007

Department of Civil and Coastal Engineering
University of Florida
365 Weil Hall
P.O. Box 116580
Gainesville, FL 32611-6580

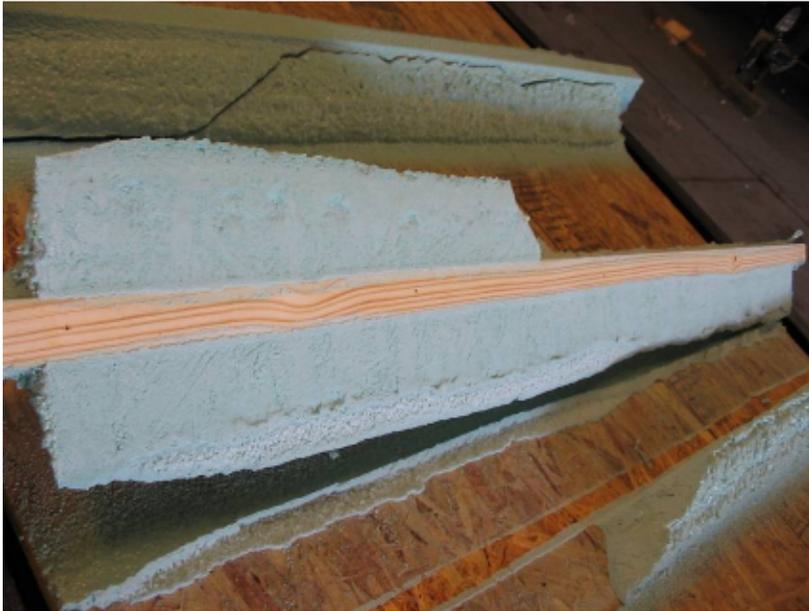
Photo 7

Three different types of failure modes were observed for Configuration A (Photos 7 and 8), described below.

1. *Separation of the wood member from the foam.* This foam separation from the wood member was sometimes an adhesive fracture evidenced by little or no foam residue remaining on the wood member. Sometimes we observed a cohesive failure evidenced by significant foam residue remaining on the wood member.

Failure of Configuration A panel showing underside of wood member and crack patterns in foam.

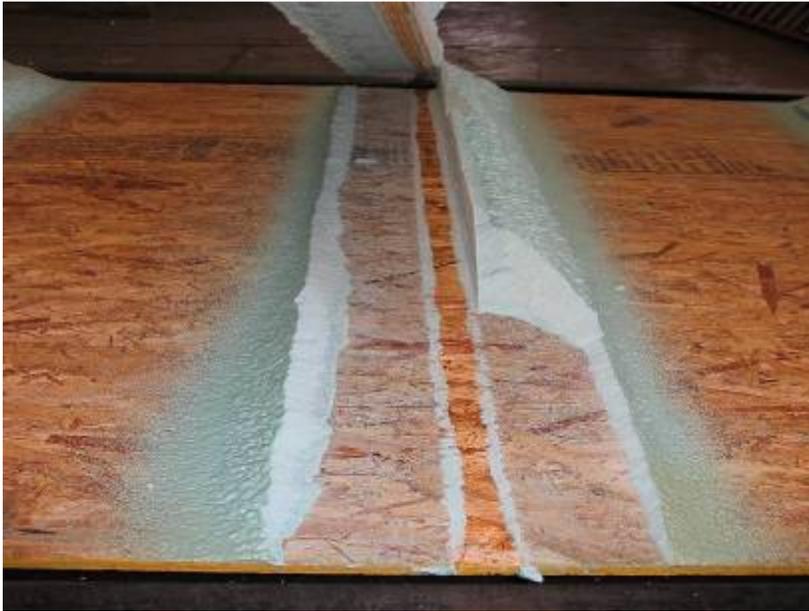
Photo 8

Failure of configuration A.

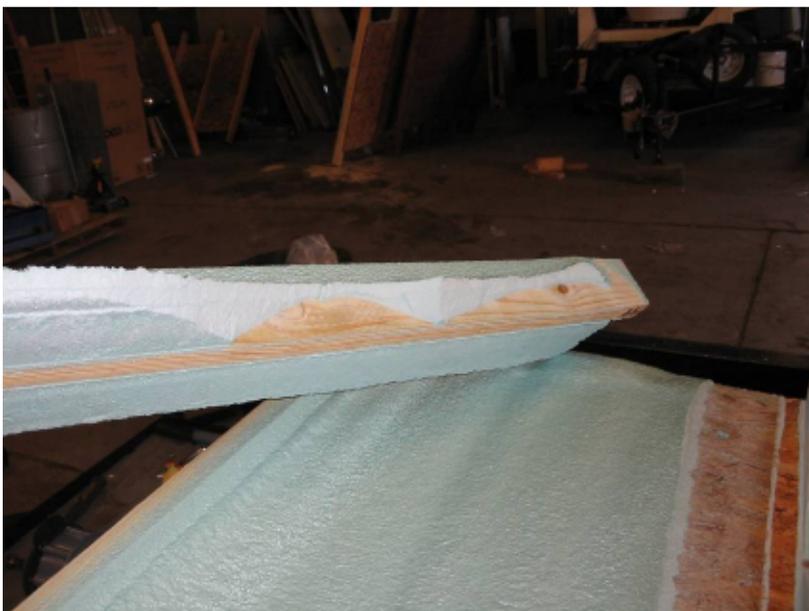
Photo 9

For Configuration B, the typical failure modes (Photos 9 and 10) were nearly identical to that of Configuration A. The ½" foam infill did not separate from the OSB sheathing during the testing. When the ½ in. foam layer fractured, the width of the fractured foam strip was approximately equivalent to the fillet width (~3 in.) Therefore, the failures were the same as for Configuration A.

Failure of configuration B where the ccSPF was detached from wood.

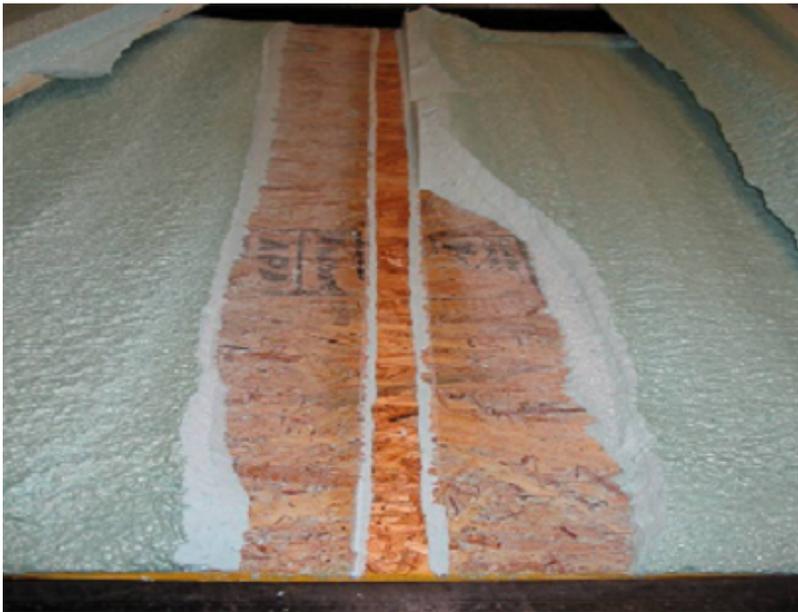
Photo 10

Failure of 1/2 in. foam layer showing ccSPF detached from wood on left side of member and ripped on right side of member.

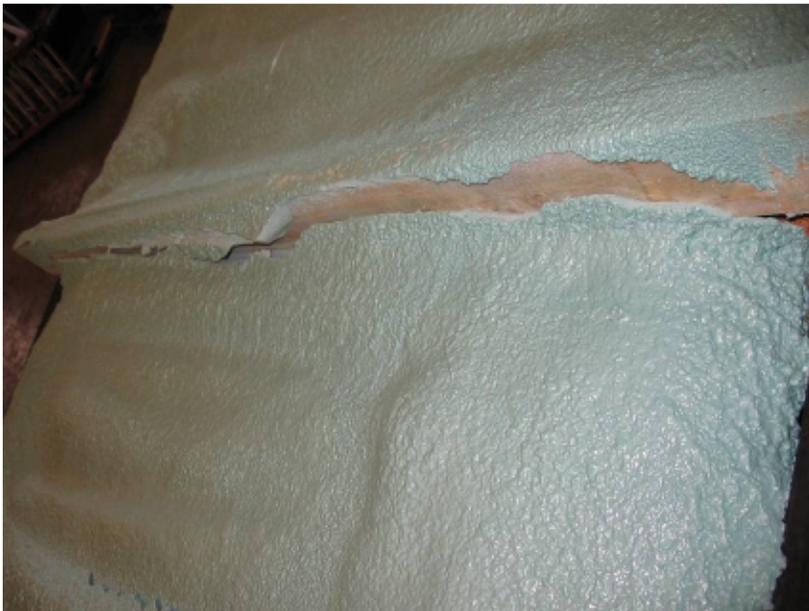
Photo 11

There were four different types of failure modes for the Configuration C specimens (Photos 11 and 12).

Cracking of fillet in 3 in. foam layer at failure.

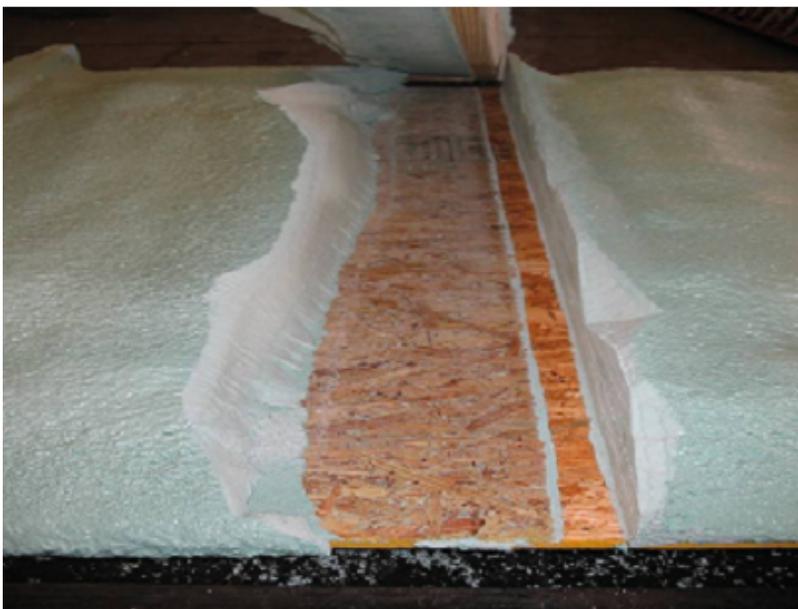
Photo 12

sheathing. The separation from the wood member was sometimes an adhesive fracture evidenced by no foam residue on the wood member and sometimes a cohesive failure evidenced by significant foam residue remaining on the wood member. Sometimes when separation occurred from the wood member, approximately half of the wood member (in the 3.5 in. dimension) would have significant foam residue remaining and the other half would not (mixed failure). This is most likely due to one of the lifts of foam achieving a stronger bond with the wood than the other lift.

Failure of 3 in. foam layer where ccSPF was detached from the wood on the left side of the member and sheared on the right side.
