Statistical and analytical models for roof components in existing light-framed wood structures

Bagyalakshmi Shanmugam^a, Bryant G. Nielson^{a,*}, David O. Prevatt^{b,1}

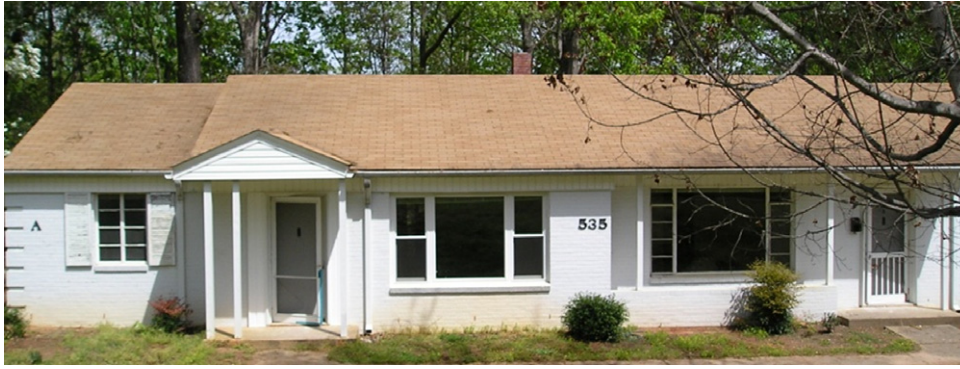
Fig. 1. Douthit Hills duplex residential structure.

The experimental tests were carried out on roof components found in four identical houses located in the Douthit Hills residential community on the campus of Clemson University, Clemson, South Carolina, USA. The houses are typical residential wooden structures constructed 50–60 years ago. These gable roofed duplex houses, scheduled for demolition, offered an excellent opportunity to study the in-situ uplift capacity of an appreciable number of toe nail connections and also to collect roof panel specimens for testing the uplift capacity of sheathing in the laboratory. Fig. 1 shows a photo of one of the four houses having plan dimensions of 8.23 m (27 ft) wide by 20.73 m (68 ft) long. The roof frames were stick built using dimensional lumber and were made up of 38 × 140 mm (nominal 2 × 6 in.) or 38 × 89 mm (nominal 2 × 4 in.) horizontal ceiling joists and 38 × 140 mm (nominal 2 × 6) rafters. A layout of the structure and the roof framing is given in Fig. 2. Framing members are spaced at 0.41m (16 in.) on the center and every fourth rafter was reinforced using a collar tie. The rafters were placed at a 6:12 pitch and attached at their lower ends to the side of the ceiling joist by means of three 3.3 mm (0.131 in.) diameter, 63.5 mm (2.5 in.) long smooth shank 8-d common nails. The ceiling joist was attached to the wall top plate using either two or three 4.1 mm (0.161 in.) diameter, 89 mm (3½ in.) long smooth shank 16-d common nails as illustrated in Fig. 3. The roof sheathing was made up of solid wooden planks of 19 mm thick by 140 mm wide (nominal 1 × 6 in.). Each plank was fastened using two 3.3 mm (0.131 in.) diameter, 63.5 mm (2.5 in.) long smooth shank 8-d common nails to each rafter. Asphalt shingles covered the sheathing planks and the building exterior was covered with brick veneer and vinyl siding. Visual inspection
